EXTERIOR WOODWORK

NUMBER 2

Paint Removal from Wood Siding

TRUMAN HOME HARRY S TRUMAN NATIONAL HISTORIC SITE Independence, Missouri

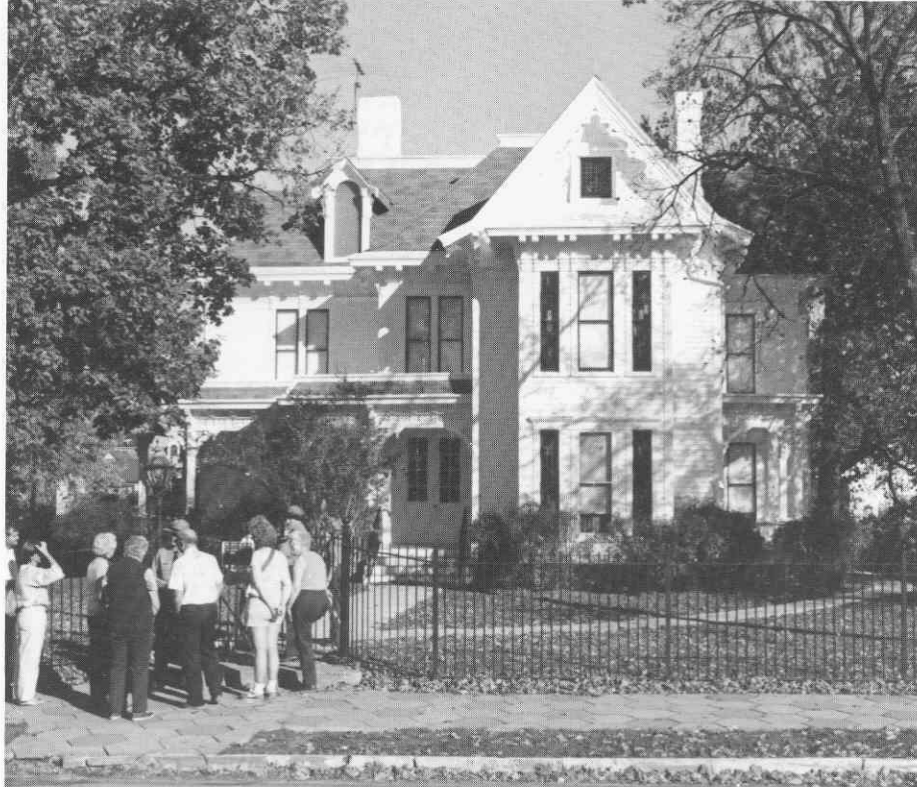
Harry S Truman National Historic Site anchors one end of a local historic residential district in the city of Independence, located just east of Kansas City, Missouri. The Truman home was constructed in three major phases. The initial pre-Civil War construction is believed to have consisted of a simple two-story rectangular structure. Major additions in 1867 and 1884 enlarged the building to 15 rooms, totaling approximately 4000 square feet. Characteristic of the early Queen Anne style, the wood-sided exterior of the 2½ story frame home was embellished with over 200 wooden brackets, decorative jig-sawn porch frieze boards, and layered cornice mouldings.

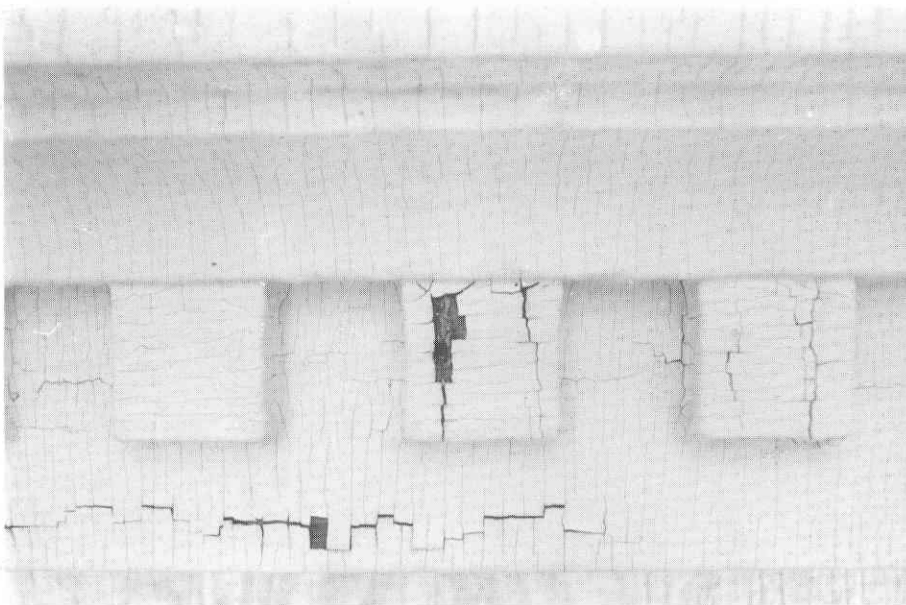
Examination of the exterior paint finishes in areas directly exposed to the elements revealed severe paint film failure, including cross-grain cracking, alligatoring, and peeling (see figure 1). Even in places shielded by porches and cornices, moderate paint film failure had occurred. A number of exposed areas, including soffits, fasciae, and siding, experienced near total paint failure due to recurrent moisture penetration from deteriorated roofs and built-in gutters. Windows were also in very poor condition; many exhibited loose glazing, broken glass and rotted sash. More than 20 coats of paint concealed deteriorated woodwork and cladding from direct examination. On much of the projecting mill work, the final layers of paint had been applied so heavily that stalactites in excess of one-quarter inch were apparent due to paint dripping.

Figure 1. Detail of a cornice dentil shows the severe cracking and failure of paint finish. Photo: Alan O'Bright

bathroom causing the paint to peel off in hand-size sheets. It was clear the exterior finishes had lost most, if not all, of their elastic integrity. In order to achieve a sound surface for painting, the decision was made to remove a majority of the exterior paint finishes to bare wood in preparation for a three-coat paint application.

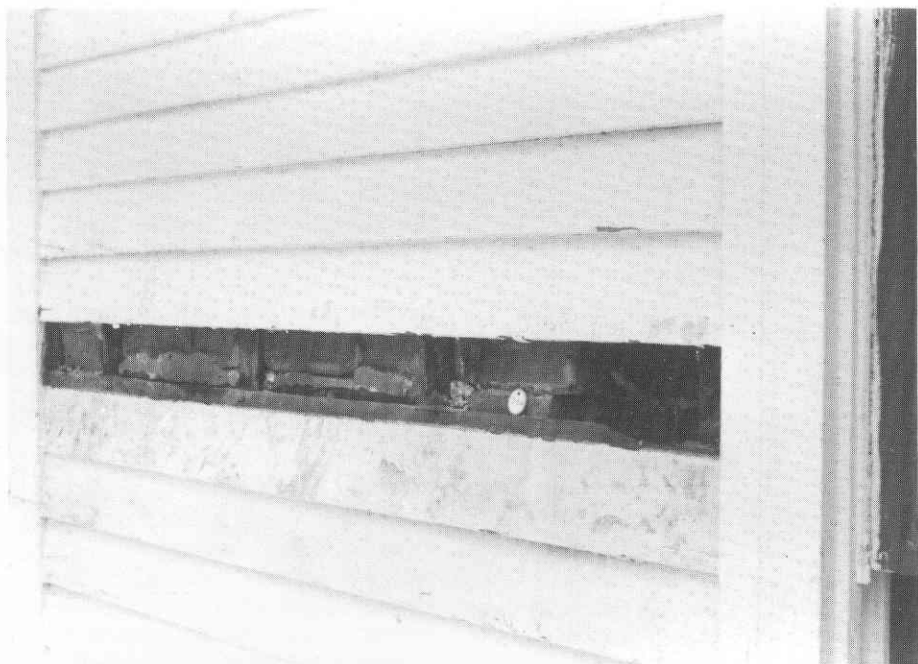
As part of the planning required before the selection of the paint removal method, a physical investigation was conducted of the exterior structure to determine the method of construction and condition (see figure 2). This is particularly critical whenever paint removal is planned. Decisions as to which paint removal methods will be used—especially methods involving heat—are in part guided by the potential flammability of the wall material and debris in the wall cavity and cornices. Sections of lapped siding were carefully removed and the underlying board sheathing cut with a hole saw to reveal the wall cavities. Fortunately, the bulk of the balloon-framed structure was found to be in good condition and the project team believed that potential fire risks could be minimized. With the exception of the 1884 addition, all wall cavities had been filled from foundation sill to soffit with soft brick and mortar. A majority of the house was

Figure 2. In assessing the safety of using thermal heat to remove paint from the siding, an investigation was performed to determine wall construction and condition. In this portion of the structure, there was no sheathing backing the siding but brick nogging extended from the foundation to the soffit. Photo: Alan O'Bright

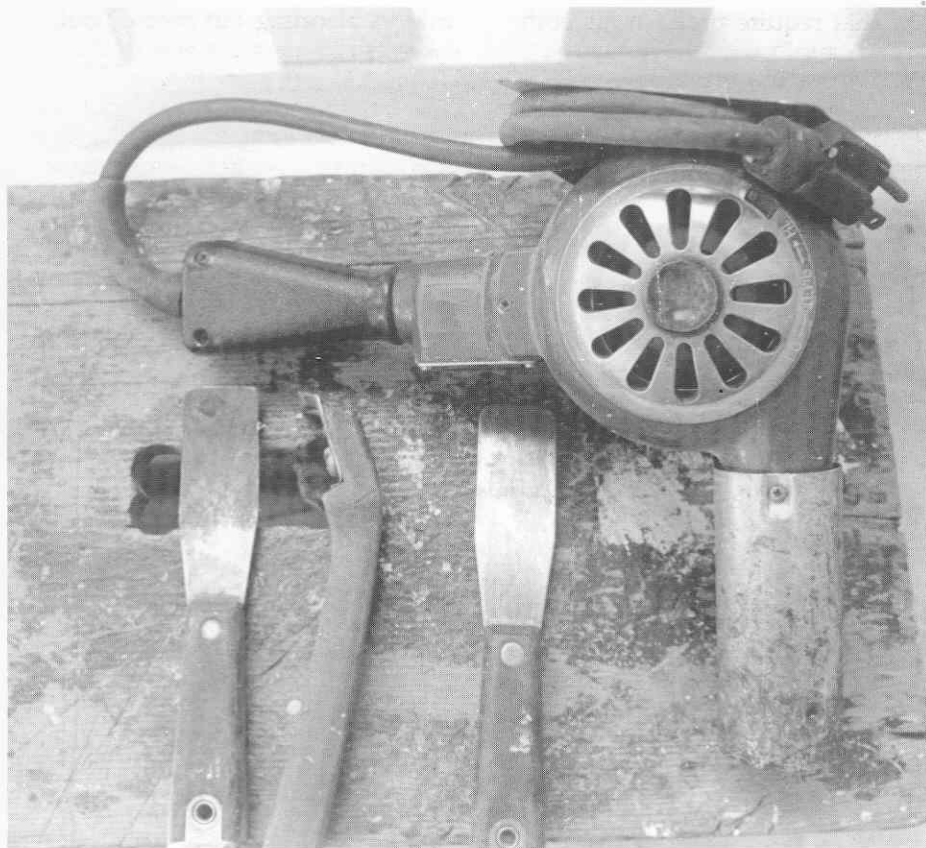
A heavy-duty heat gun was approved for the contractor's use (see figure 3). The metal encased unit featured variable heat control (500-750° F) through adjustable side vents, and a cool down switch, which extends the life of the replaceable heating elements. Since these elements can have a working life as short as 60 to 80 hours, extra elements were purchased and were available at the site for immediate replacement of those in the five heat guns used in the project.

Figure 3. Heat guns, putty knives with corners rounded, and paint scrapers were used in paint removal. Photo: Michael Lee

During paint removal the scraped paint tended to adhere to the putty knife, slowing the paint removal process. The workers tried several putty knives and scrapers, but none was successful in shedding the paint residue from the blade. Therefore, the knives had to be periodically cleaned of gummed paint with another putty knife. For siding, a 2 to 2½ inch-wide rigid putty knife worked best. Narrower blades were used for millwork and tight spots. To reduce chances of the workers gouging the wood with the putty knives, the edges of the blades were rounded using a grinder.

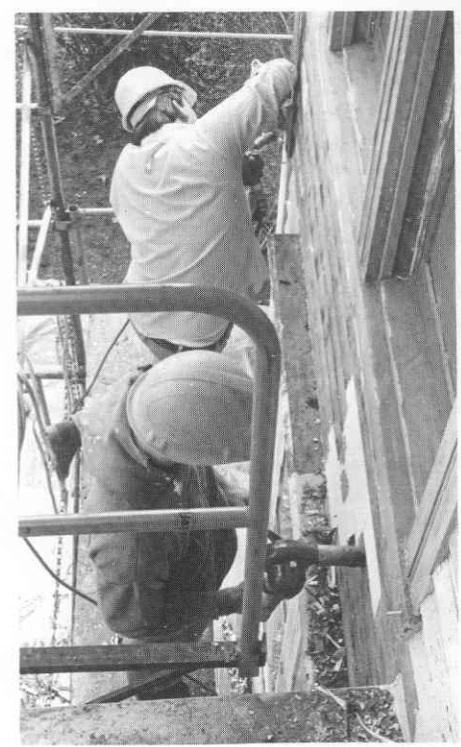
Figure 5. Using scaffolding, workers remove the paint with heat guns. Cracked or deteriorated siding was repaired or replaced. Photo: Alan O'Bright

The siding was inspected for rot and cracks, and suspect sections were marked for repair or replacement. The marked sections were passed over in the paint removal process.

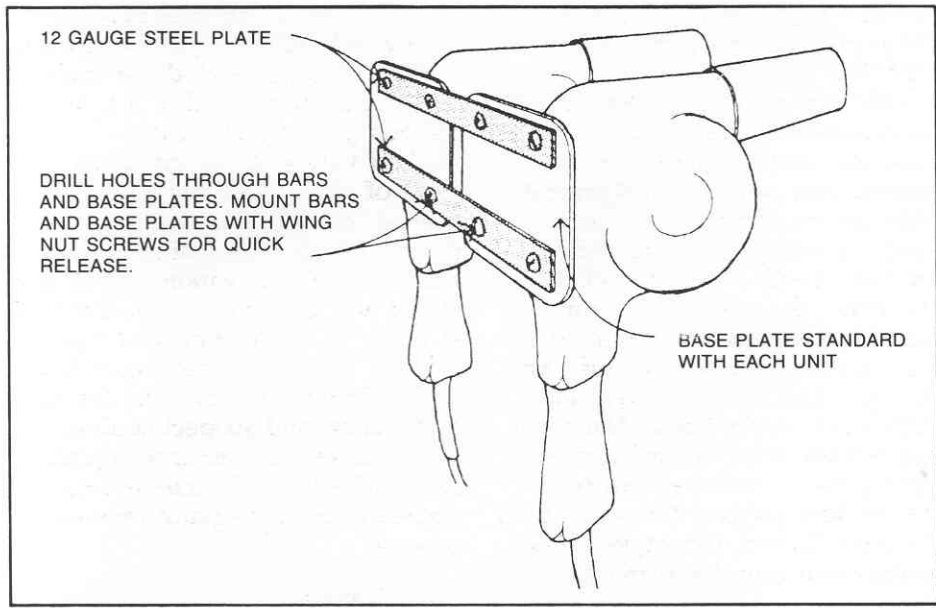
worker alternately heated and scraped the surface. Time was lost in this method because the heat gun had to be set down periodically in order for the worker to clean his putty knife. The second technique, developed by the contractor's site supervisor, was to fasten two heat guns together side by side using metal bars bolted to each gun base (see figure 4). In this way one worker heated the surface while another scraped in a continuous process. This method worked very well for expansive areas of siding and attained an average rate of 8 to 10 square feet per crew hour. On siding in tight areas where one worker operated a single heat gun, paint was removed at a rate of approximately 4 square feet per crew hour (see figure 5).

Figure 4. Method used to join two heat guns for simultaneous use. Drawing: Alan O'Bright

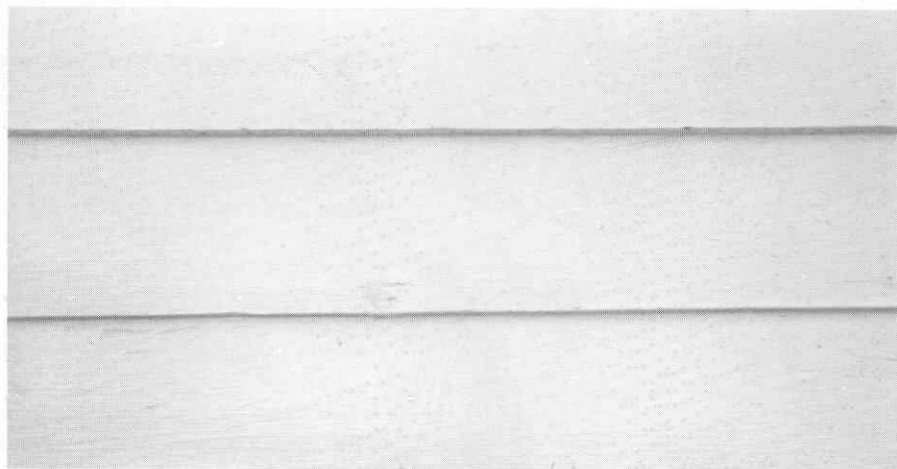
Areas on the Truman home where paint was removed with the heat guns and then lightly sanded provided an excellent painting surface (see figure 6). By using workers experienced with thermal removal of paint, very few scraper tool marks were left that were noticeable. The new paint bonded well to the wood

Figure 6. A typical section of the finish painted siding shows that little damage was done in removing the paint. Photo: Michael Lee
